# Microstructural Investigation of High Emittance Glass Coatings on Fibrous Ceramic Insulation

Don Ellerby, Dan Leiser, Robert Di Fiore,  
Jeff Figone and Dane Smith  
NASA Ames Research Center  
Moffett Field, CA  
dellerby@mail.arc.nasa.gov

**Thermal Protection Materials and Systems Branch**

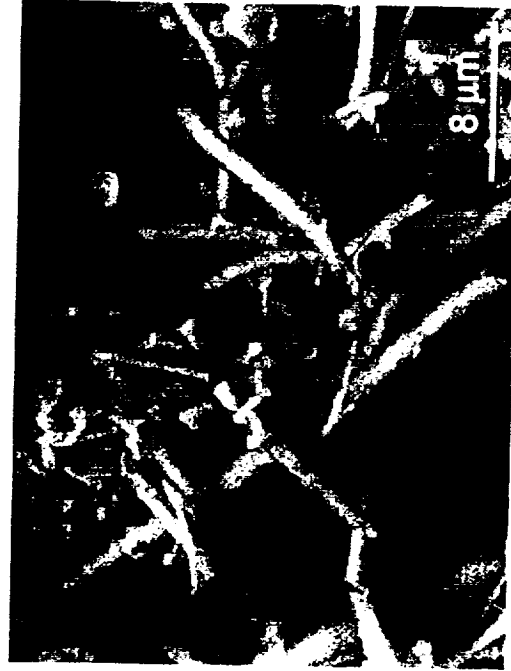
LI-900 Pure Silica Tile

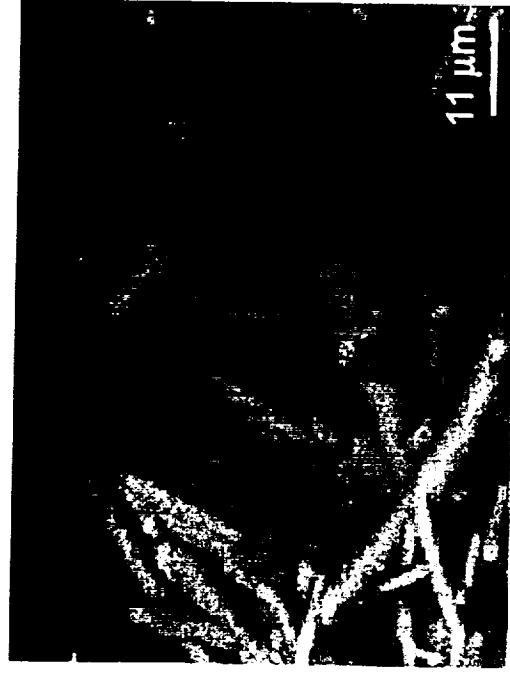
AETB Tile

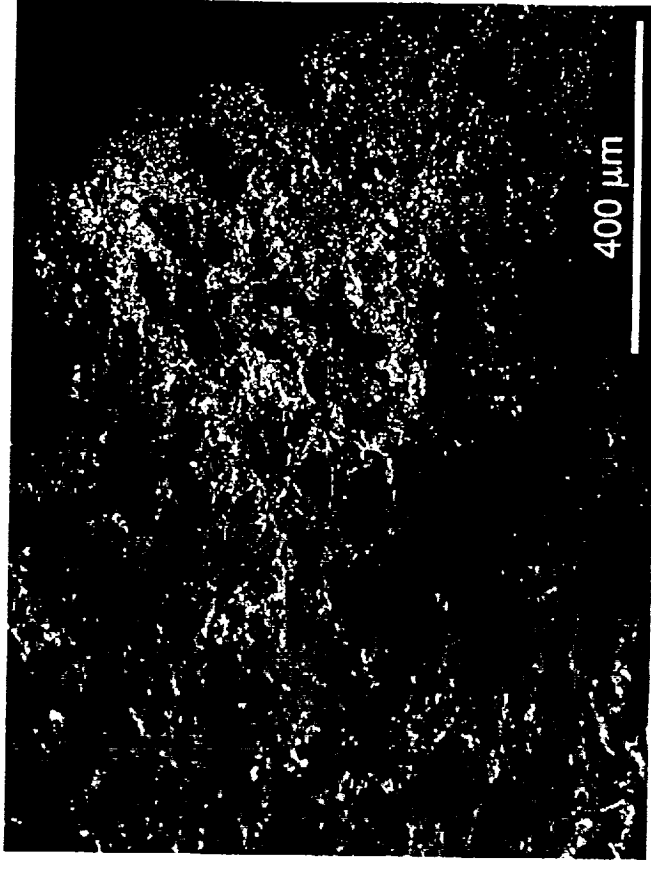
# Toughened Uni-Piece Fibrous Insulation (TUFI)

- High Emittance  $\epsilon > 0.8$
- 2.5 mm thick
- Compatible with tile
  - no devitrification
- Porous coating
- Material penetrates into the tile
  - smaller particle size
- Significantly improved impact resistance
- $\text{MoSi}_2$  act as emissivity agent
  - also increases CTE so it matches that of AETB tiles.

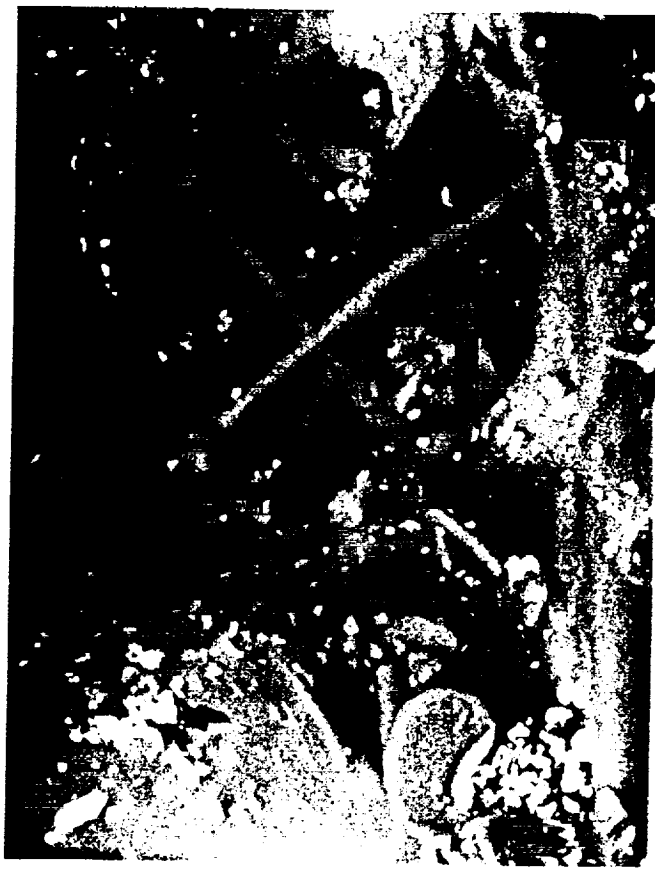
# Microstructure of TUF-I System

- TUF-I is applied as three separate coats.
- Results in a graded coating system that is denser near the surface.
- Two scales of porosity
  - regions that appear deficient in glass
  - denser regions also have a smaller scale porosity
